Landscape Literacy: Addressing Critical Ecohydrology Issues within their Drainage Ecosystem Context

Hugh Pringle, Ibo Zimmermann, Kuniberth Shamathe and Colin Nott
Ecosystem Management Understanding (EMU)™ and Edith Cowan
University, PO Box 8522, Alice Springs, NT 0871, Australia
hpringle1@bigpond.com

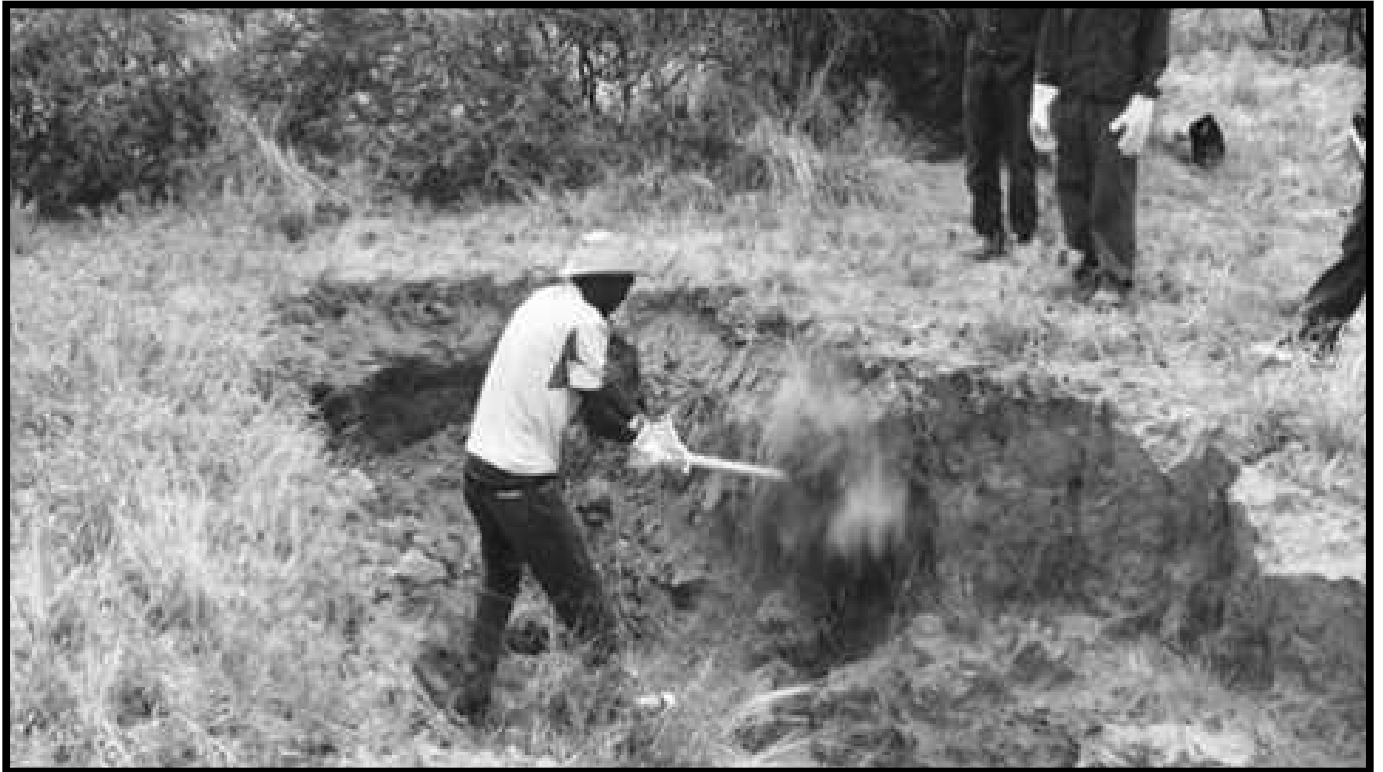
Figure 1. A pick is used to break down steep gully heads to avoid injury of cattle.

- (1) a kraal around a large gully head, into which cattle were herded for two successive nights to trample down and smoothen the steep gully walls while fertilizing the soil (Figures 1 and 2);
- (2) strategically placed filters in rills and gully heads, comprising branches of thorn bushes tied down with wire secured to nearby trees or steel posts hammered into the ground (Figure 3);
- (3) suspended filters across pinch points in gullies where fierce water flow can be calmed down as it lifts the hanging branches while flowing underneath without ripping them off the wire (Figure 4).

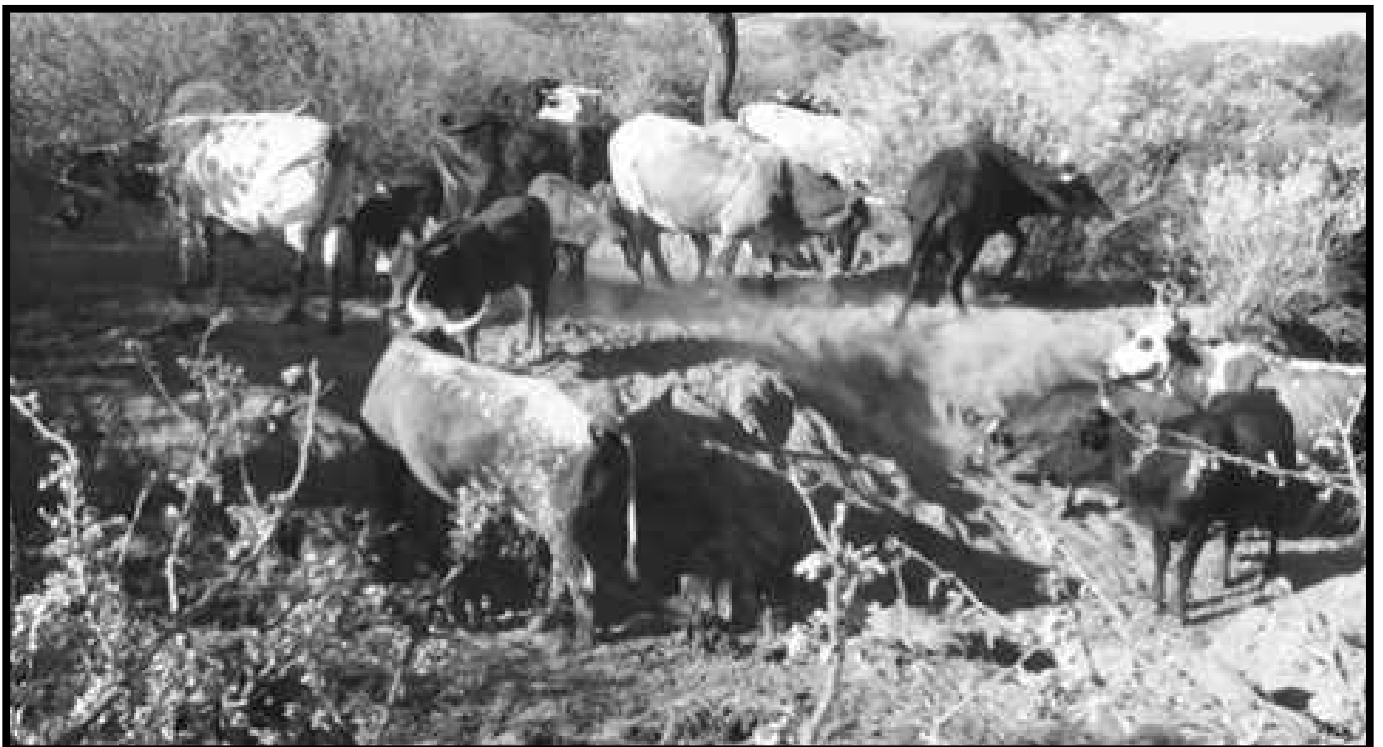
Figure 2. Cattle further smoothen gully heads while preparing a seed bed and fertilizing the soil.

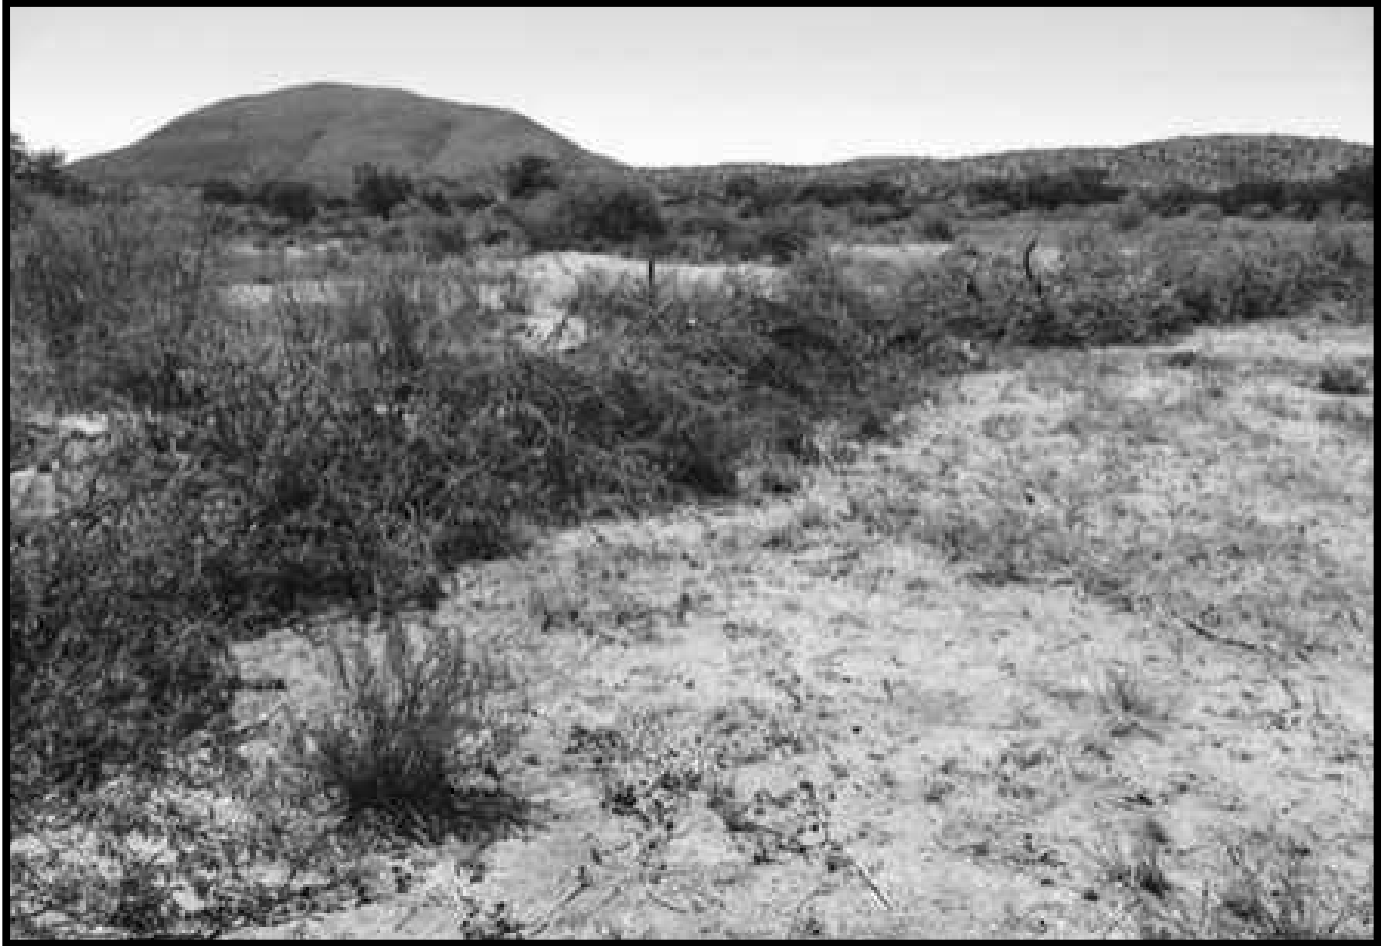
Figure 3. A filter of thorn bushes was tied down at a gully head.

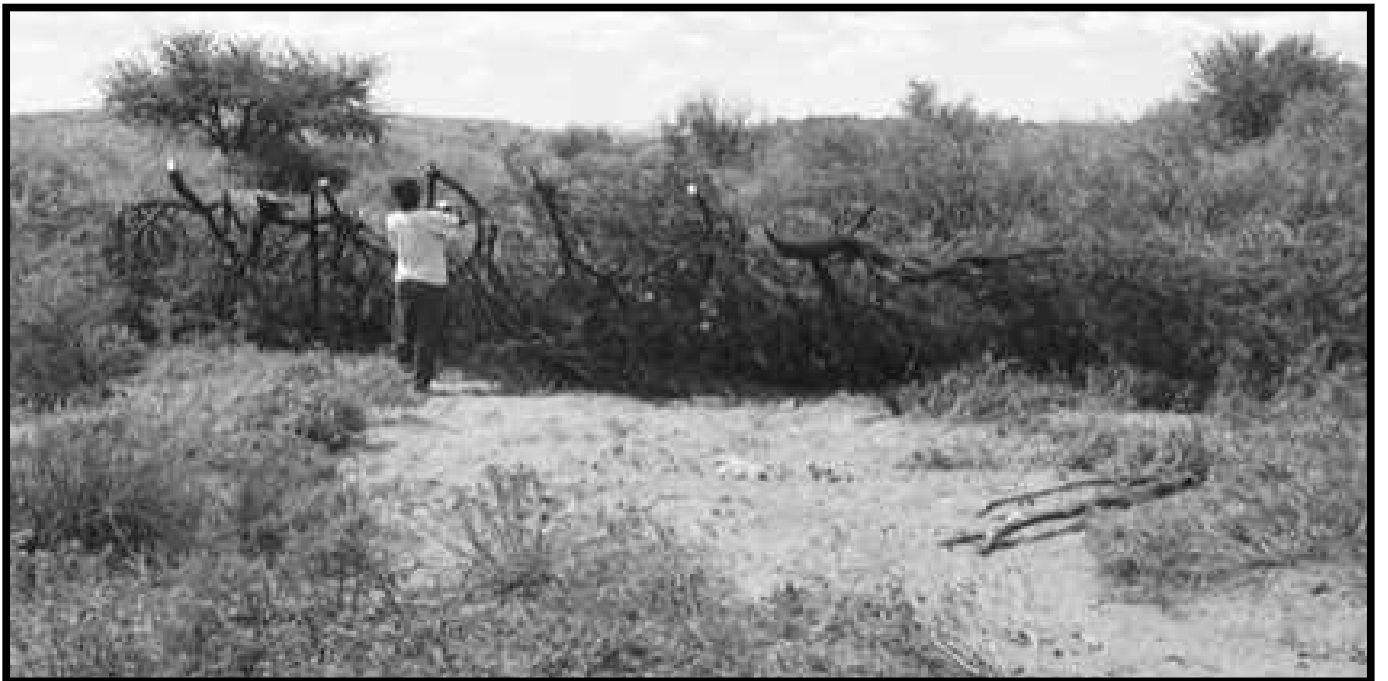
Figure 4. A filter is suspended from wire tied across a gully.
